**Flood Control Project Maintenance
Levee Inspections****LMA District Cover Sheet
Spring 2015 Levee Inspection Results****Levee District No. 0001 (Glenn County)**

Spring 2015 Levee Inspection Results

Levee District No. 0001 (Glenn County)

Waterway			Bank	Unit Miles
Unit No. 01 Sacramento River			Right	12.23
	Spring (March - May)	Summer (June - August)	(September - November) Fall	Winter (December - February)
Unit Maintenance Rating (Fall Only)				
Date of Inspection	04/07/2015 - 04/07/2015			
DWR Inspector	Bob Duffey			
Accompanied By	Bill Carriere

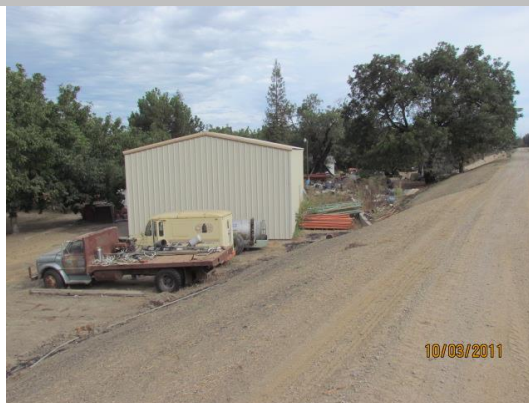
Photo 1 of 1 : SP_2015_LD0001G_432_4_20150310_00002.jpg

LM Start	1.07	Rating **	M	Issue No.	4
LM End	1.30	Issue Type +	En	Location *	LS
Category	Earthen Levee			GPS Latitude/Longitude	
				Start	End
Item	Encroachments			39.491887 °	39.494572 °
				-122.020238 °	-122.017840 °
DWR ID	DWR_LD0001G_01_s_2012_4				
Action/Comments					
Building

View of vehicles & equipment along the L/S toe.

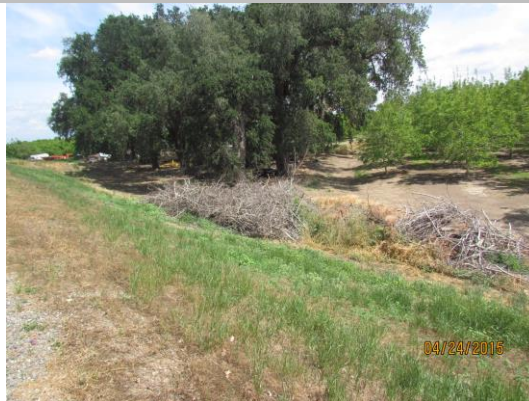
Photo 1 of 1 : SP_2015_LD0001G_432_58_20150428_00048.jpg

LM Start	1.15	Rating **	M	Issue No.	58
LM End	1.15	Issue Type +	En	Location *	WS
Category	Earthen Levee			GPS Latitude/Longitude	
				Start	End
Item	Encroachments			39.492788 °	39.492788 °
				-122.019437 °	-122.019437 °
DWR ID	DWR_LD0001G_01_s_2015_58				
Action/Comments					
Prunings					
Inspector Comments: Remove the prunings from the waterside toe.

View of the prunings along the waterside toe.

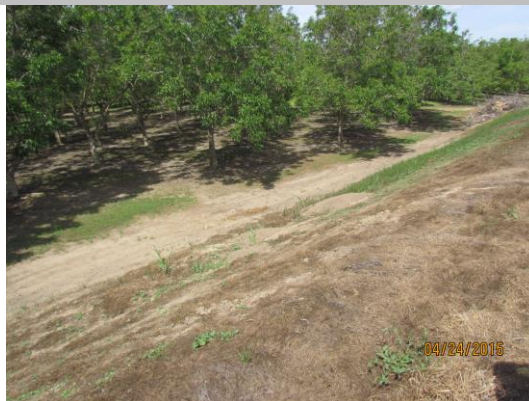
Photo 1 of 1 : SP_2015_LD0001G_432_59_20150428_00049.jpg

LM Start	1.22	Rating **	A/W	Issue No.	59
LM End	1.22	Issue Type +	Ma	Location *	LS
Category	Earthen Levee			GPS Latitude/Longitude	
				Start	End
Item	Animal Control			39.493667 °	39.493667 °
				-122.018643 °	-122.018643 °
DWR ID	DWR_LD0001G_01_s_2015_59				
Action/Comments					
No rodents visible, but rodent burrows visible; need to backfill and compact or grout burrows. Inspector Comments: The levee district has a rodent program in place.

View of the rodent holes along the landside slope.

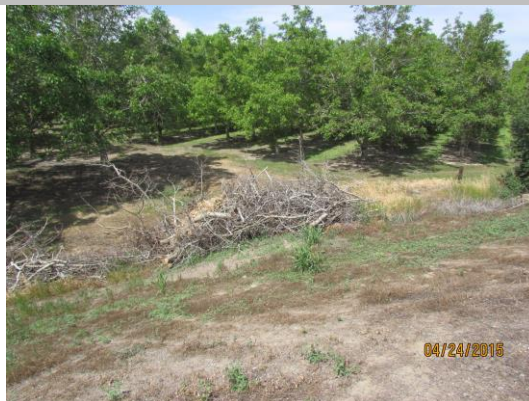
Photo 1 of 1 : SP_2015_LD0001G_432_60_20150504_00050.jpg

LM Start	1.25	Rating **	M	Issue No.	60
LM End	1.25	Issue Type +	En	Location *	LS
Category	Earthen Levee			GPS Latitude/Longitude	
				Start	End
Item	Encroachments			39.494033 °	39.494033 °
				-122.018327 °	-122.018327 °
DWR ID	DWR_LD0001G_01_s_2015_60				
Action/Comments					
Prunings					
Inspector Comments: Remove the prunings from the landside toe.

View of the prunings along the landside toe.

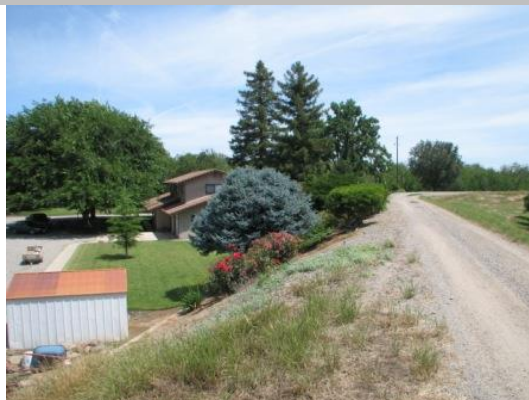
Photo 1 of 1 : SP_2015_LD0001G_432_6_20150310_00003.jpg

LM Start	1.32	Rating **	M	Issue No.	6
LM End	1.36	Issue Type +	En	Location *	LS
Category	Earthen Levee			GPS Latitude/Longitude	
				Start	End
Item	Vegetation			39.494828 °	39.495330 °
				-122.017632 °	-122.017163 °
DWR ID	DWR_LD0001G_01_s_2012_6				
Action/Comments					
Landscaping

View of the permitted landscape on the landside slope of the levee.

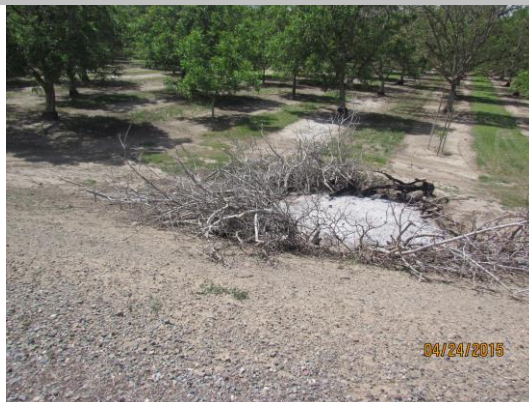
Photo 1 of 1 : SP_2015_LD0001G_432_61_20150504_00051.jpg

LM Start	2.48	Rating **	M	Issue No.	61
LM End	2.48	Issue Type +	En	Location *	LS
Category	Earthen Levee			GPS Latitude/Longitude	
				Start	End
Item	Encroachments			39.505237 °	39.505237 °
				-122.006493 °	-122.006493 °
DWR ID	DWR_LD0001G_01_s_2015_61				
Action/Comments					
Prunings

View of the prunings along the landside toe.

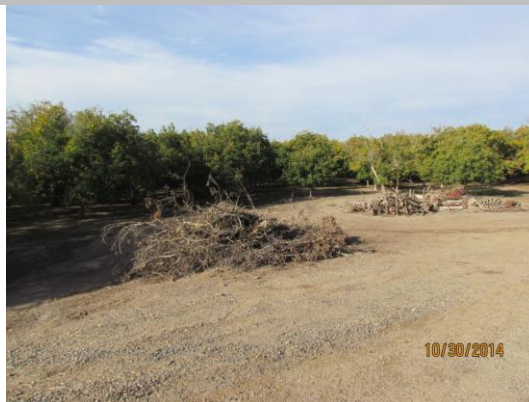
Photo 1 of 1 : SP_2015_LD0001G_432_49_20150310_00015.jpg

LM Start	2.80	Rating **	M	Issue No.	49
LM End	2.80	Issue Type +	En	Location *	LS
Category	Earthen Levee			GPS Latitude/Longitude	
				Start	End
Item	Encroachments			39.509503 °	39.509503 °
				-122.008732 °	-122.008732 °
DWR ID	DWR_LD0001G_01_f_2014_49				
Action/Comments					
Prunings

View of the prunings along the landsides toe.

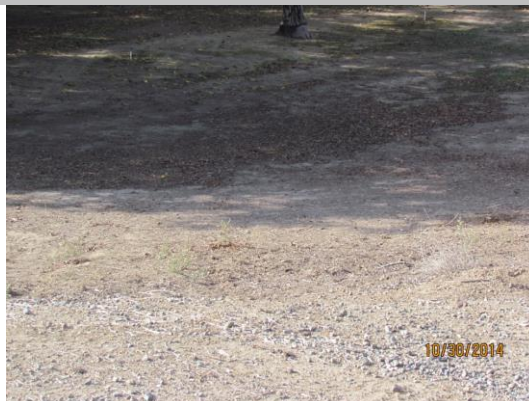
Photo 1 of 1 : SP_2015_LD0001G_432_50_20150310_00016.jpg

LM Start	2.80	Rating **	A/W	Issue No.	50
LM End	2.80	Issue Type +	Ma	Location *	LS
Category	Earthen Levee			GPS Latitude/Longitude	
				Start	End
Item	Animal Control			39.509503 °	39.509503 °
				-122.008732 °	-122.008732 °
DWR ID	DWR_LD0001G_01_f_2014_50				
Action/Comments					
No rodents visible, but rodent burrows visible; need to backfill and compact or grout burrows.

View of the rodent activity along the landside slope.

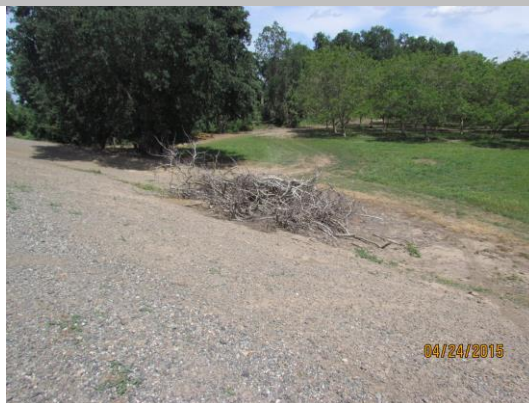
Photo 1 of 1 : SP_2015_LD0001G_432_62_20150504_00052.jpg

LM Start	2.87	Rating **	M	Issue No.	62
LM End	2.87	Issue Type +	En	Location *	WS
Category	Earthen Levee			GPS Latitude/Longitude	
				Start	End
Item	Encroachments			39.510492 °	39.510492 °
				-122.009023 °	-122.009023 °
DWR ID	DWR_LD0001G_01_s_2015_62				
Action/Comments					
Prunings					
Inspector Comments: Remove the pruning from the waterside toe.

View of the pruning on the waterside toe.

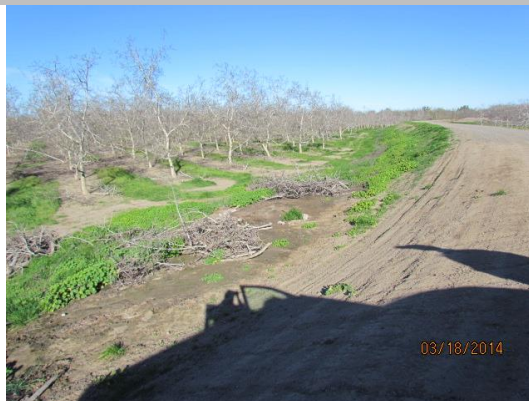
Photo 1 of 1 : SP_2015_LD0001G_432_45_20150310_00011.jpg

LM Start	3.04	Rating **	M	Issue No.	45
LM End	3.04	Issue Type +	En	Location *	LS
Category	Earthen Levee			GPS Latitude/Longitude	
				Start	End
Item	Encroachments			39.512914 °	39.512914 °
				-122.009063 °	-122.009063 °
DWR ID	DWR_LD0001G_01_s_2014_45				
Action/Comments					
Prunings

View of the removed prunings from the l/s slope.

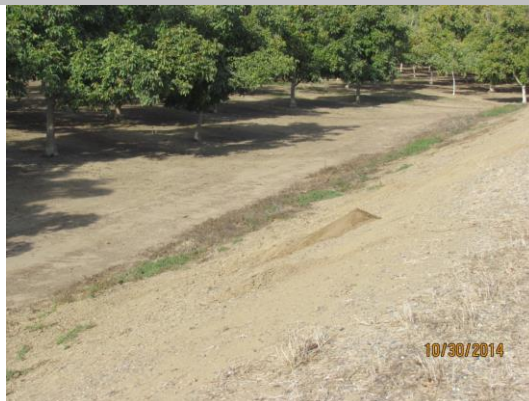
Photo 1 of 1 : SP_2015_LD0001G_432_51_20150310_00017.jpg

View of the rodent activity along the landside slope.

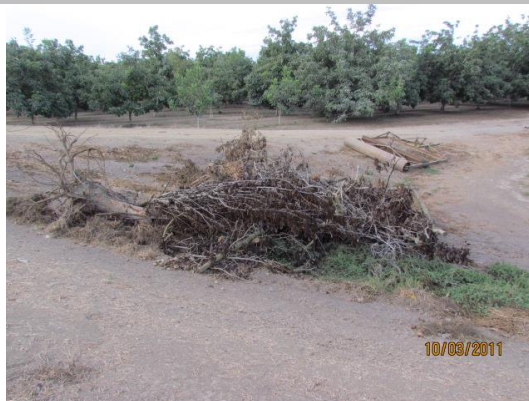
Photo 1 of 1 : SP_2015_LD0001G_432_16_20150310_00009.jpg

LM Start	3.17	Rating **	M	Issue No.	16
LM End	3.17	Issue Type +	Ma	Location *	LS
Category	Earthen Levee			GPS Latitude/Longitude	
				Start	End
Item	Encroachments			39.514378 °	39.514378 °
				-122.010306 °	-122.010306 °
DWR ID	DWR_LD0001G_01_s_2012_16				
Action/Comments					
Prunings

View of the pruning pile along the L/S toe.

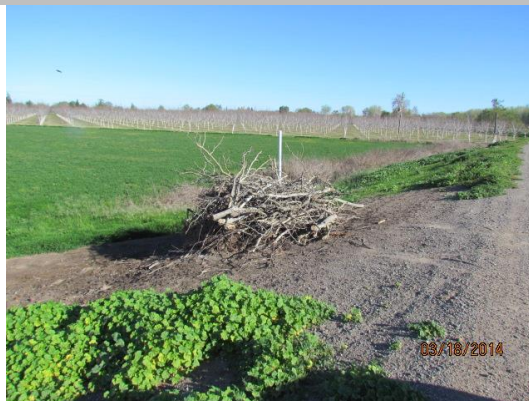
Photo 1 of 1 : SP_2015_LD0001G_432_46_20150310_00012.jpg

View of the prunings along the landside slope.

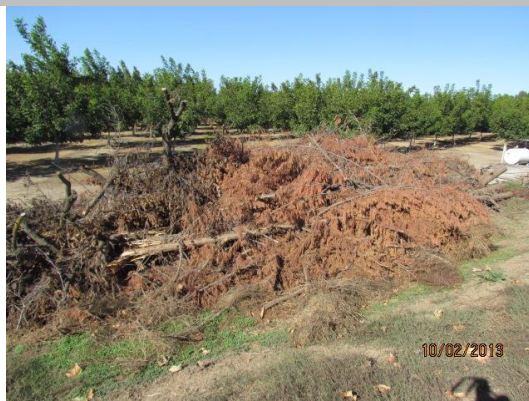
Photo 1 of 1 : SP_2015_LD0001G_432_56_20150310_00022.jpg

LM Start	3.63	Rating **	M	Issue No.	56
LM End	3.63	Issue Type +	En	Location *	LS
Category	Earthen Levee			GPS Latitude/Longitude	
				Start	End
Item	Encroachments			39.520623 °	39.520623 °
				-122.010457 °	-122.010457 °
DWR ID	DWR_LD0001G_01_f_2013_56				
Action/Comments					
Prunings

View of the prunings & limbs along the slope of the levee.

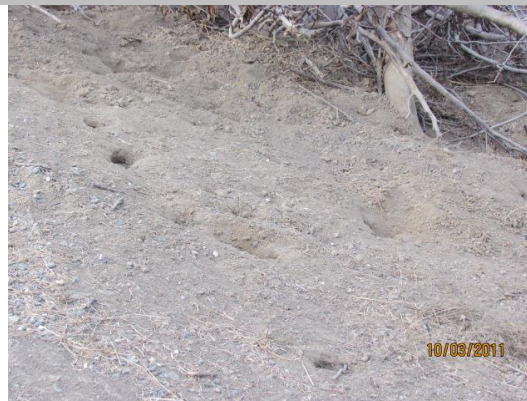
Photo 1 of 1 : SP_2015_LD0001G_432_395_20150310_00024.jpg

View of the rodent holes along the L/S toe.

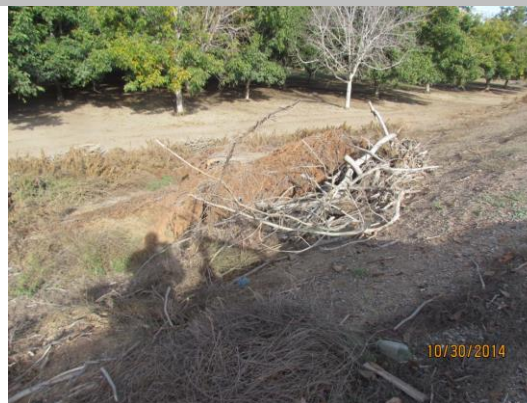
Photo 1 of 1 : SP_2015_LD0001G_432_52_20150310_00018.jpg

LM Start	3.88	Rating **	M	Issue No.	52
LM End	3.88	Issue Type +	Ma	Location *	LS
Category	Earthen Levee			GPS Latitude/Longitude	
				Start	End
Item	Encroachments			39.523855 °	39.523855 °
				-122.010762 °	-122.010762 °
DWR ID	DWR_LD0001G_01_f_2014_52				
Action/Comments					
Prunings

View of the prunings along the landside toe.

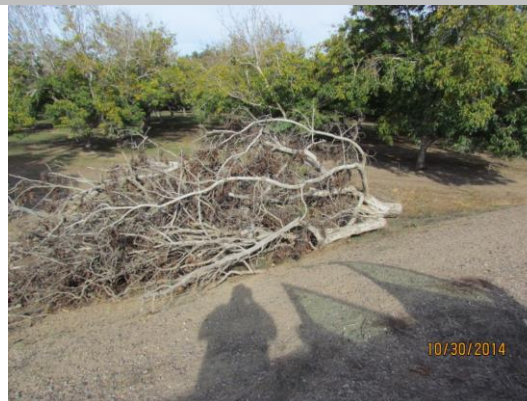
Photo 1 of 1 : SP_2015_LD0001G_432_53_20150310_00019.jpg

LM Start	3.92	Rating **	M	Issue No.	53
LM End	3.92	Issue Type +	En	Location *	LS
Category	Earthen Levee			GPS Latitude/Longitude	
				Start	End
Item	Encroachments			39.524432 °	39.524432 °
				-122.010417 °	-122.010417 °
DWR ID	DWR_LD0001G_01_f_2014_53				
Action/Comments					
Prunings

View of the prunings along the landside toe.

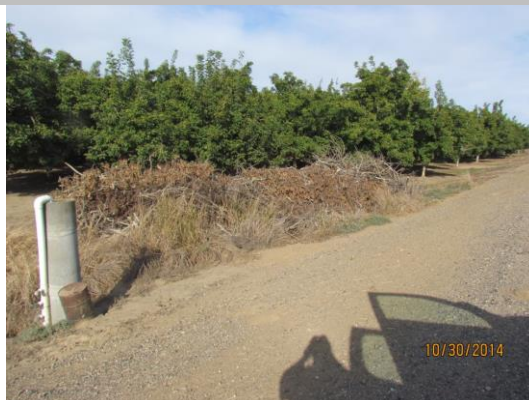
Photo 1 of 1 : SP_2015_LD0001G_432_54_20150310_00020.jpg

View of the prunings along the landside toe.

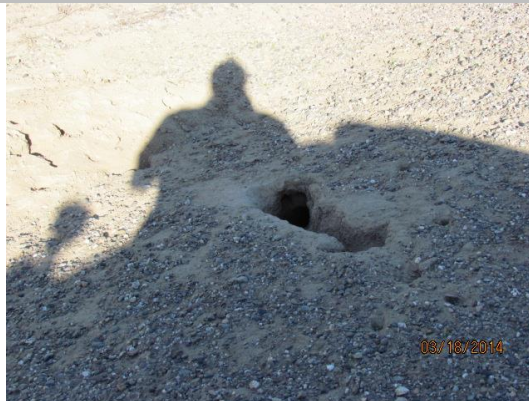
Photo 1 of 1 : SP_2015_LD0001G_432_47_20150310_00013.jpg

LM Start	6.22	Rating **	M	Issue No.	47
LM End	6.22	Issue Type +	Ma	Location *	LS
Category	Earthen Levee			GPS Latitude/Longitude	
				Start	End
Item	Animal Control			39.550533 °	39.550533 °
				-122.002319 °	-122.002319 °
DWR ID	DWR_LD0001G_01_s_2014_47				
Action/Comments					
No rodents visible, but rodent burrows visible; need to backfill and compact or grout burrows.

View of the rodent activity along the l/s slope.

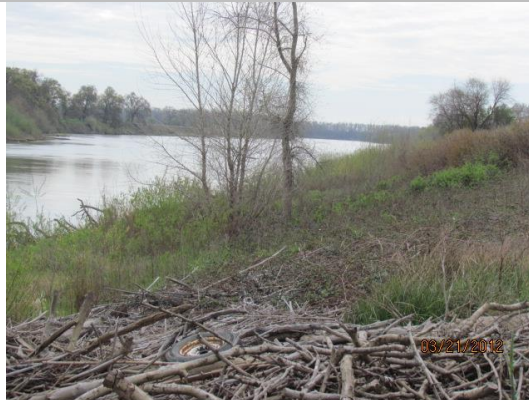
Photo 1 of 1 : SP_2015_LD0001G_432_10_20150310_00006.jpg

View of the Army Corps of Engineers mitigation site.

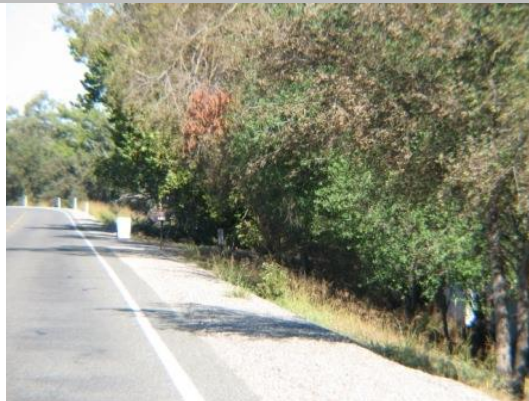
Photo 1 of 1 : SP_2015_LD0001G_432_20_20150310_00010.jpg

View of the trees and vegetation along the waterside slope of the levee.

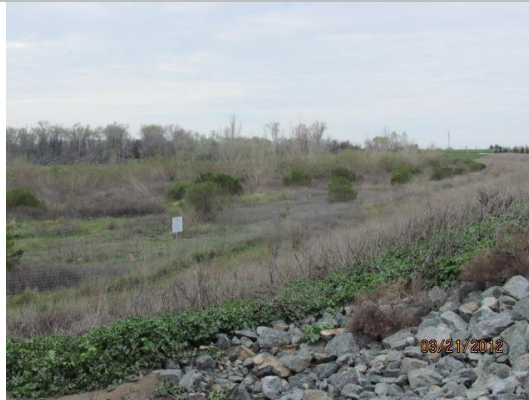
Photo 1 of 1 : SP_2015_LD0001G_432_8_20150310_00005.jpg

View of the Army Corps of Engineers mitigation site.

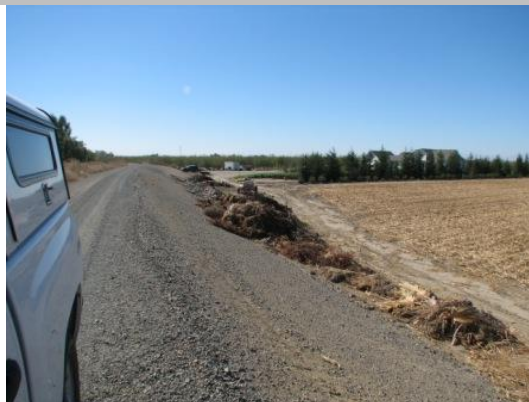
Photo 1 of 1 : SP_2015_LD0001G_432_11_20150310_00007.jpg

LM Start	9.57	Rating **	M	Issue No.	11
LM End	9.57	Issue Type +	Ma	Location *	LS
Category	Earthen Levee			GPS Latitude/Longitude	
				Start	End
Item	Encroachments			39.597078 °	39.597078 °
				-122.002127 °	-122.002127 °
DWR ID	DWR_LD0001G_01_s_2012_11				
Action/Comments					
Debris

View of debris along the toe of the levee.

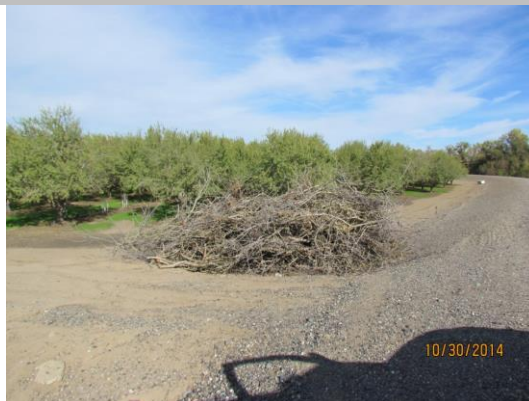
Photo 1 of 1 : SP_2015_LD0001G_432_55_20150310_00021.jpg

View of the prunings along the landside toe.

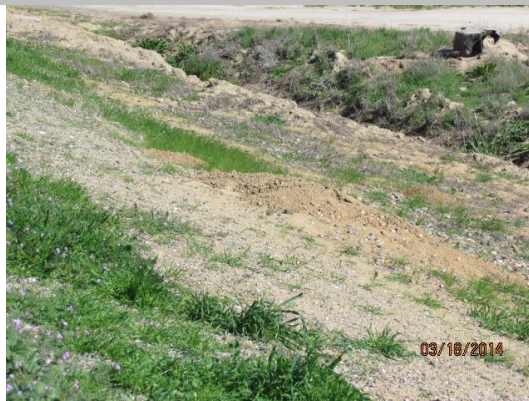
Photo 1 of 1 : SP_2015_LD0001G_432_48_20150310_00014.jpg

View of the rodent activity along the waterside slope.
